# Greening the Horizon: Possibilities of Preserving Biodiversity During the Renovation of Apartment Buildings as Manifestation of Values of European Green Deal

Anastasiia Kiuppier, Gediminas Viliūnas, Indrė Gražulevičiūtė-Vileniškė\*

*Kauno technologijos universitetas, Statybos ir architektūros fakultetas,*

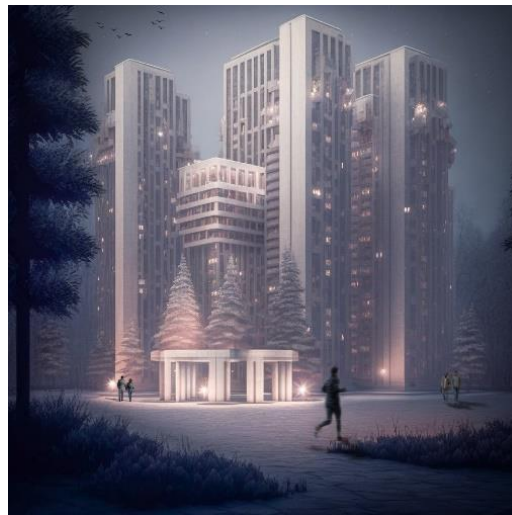
**Fig. 1.** Renovation of Soviet modernist apartment buildings designed using artificial intelligence (Arch Hive, 2024)  
*1 pav. Sovietinio laikotarpio modernistinių daugiabučių gyvenamųjų namų renovacijos siūlymas, sugeneruotas panaudojant dirbtinį intelektą (Arch Hive, 2024)*

The Arch Hive study using AI tried to combine the concept of coherence with the issue of renovating Soviet apartment buildings, as demonstrated in the Fig. 1, a rather narrow interpretation is seen in which trees could be one of the interpretations of sustainability understood by the AI, and the division of windows as the representation of modernity. However, there are lessons to be learned from such images – this gives the creator inspiration – either to improve and form a completely different, new starting point, or to continue the idea formed by the AI.

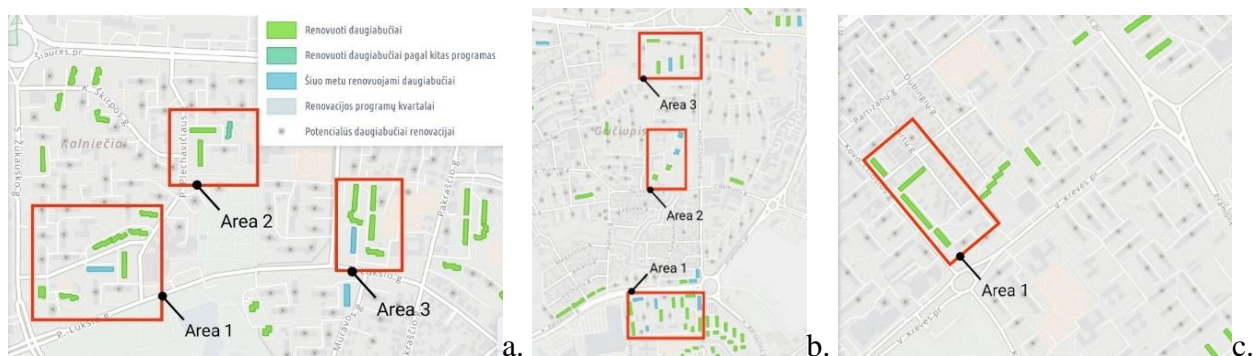
**Fig. 2.** Areas selected for observation in Kaunas: a. Eiguliai, b. Gričiupis, c., Dainava. Both shades of green represent renovated apartment buildings, blue represents buildings under renovation (Daugiabučių namų renovacijos žemėlapis, 2023)

the Eiguliai and Gričiupis neighborhoods, and one in Dainava (Fig. 2). The observation checklist was compiled, consisting of three main categories: biodiversity, livability, and renovation (Table 1). During the observation in spring months of 2023 the tables with checklist were compiled and the features of the areas and buildings were recorded in photographs, after the observation descriptive analysis of the areas was done.

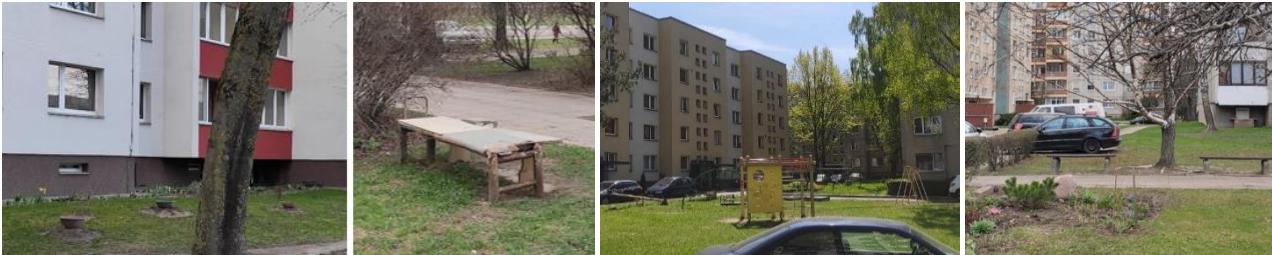
**Fig. 3.** Green areas and public space equipment, landscaping done by residents. Photographs by Anastasiia Kiuppier  
**3 pav.** Žaliosios zonos ir viešųjų erdvių įranga, gyventojų atliekamo kraštovaizdžio tvarkymo požymiai. Anastasijos Kiuppier nuotraukos

*Area 1.* The observed area comprises mostly green spaces, accounting for approximately 80% of the total area, with pavement and roads making up the remaining 20%. The vegetation consists of various tree species, while the diversity of bushes, flowers, and grass is relatively low. Wildlife, including birds and insects, is present in the area. Limited park-like spaces and well-maintained community gardens are available. Interaction with nature is evident through the presence of nesting boxes and small gardens created by residents (Fig. 3). The area is clean and free of rubbish.

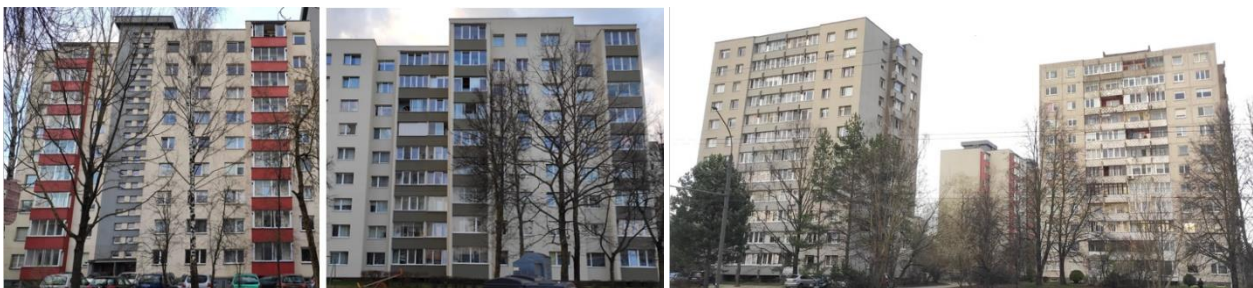
**Fig. 4.** Renovated and non-renovated buildings in the analyzed area. Photographs by Anastasiia Kiuppier  
**4 pav.** Renovuoti ir nerenovuoti pastatai analizuojamoje teritorijoje. Anastasiia Kiuppier nuotraukos

The area comprises both renovated and non-renovated apartment buildings, but there are no ongoing renovation projects (Fig. 4). Furthermore, renovated houses were not deprived of the aesthetic qualities that non-renovated houses have and there are no new details. Renovated buildings exhibit changes such as insulation, changed colors (although each building has its own color scheme without color coordination for the entire area), and covered ventilation openings that previously served as bird habitats. The buildings show no external signs of damage. Renovated facades exhibit such types of materials as wall plaster or matte large tile panels. The color palette of the renovated buildings complements the surroundings, featuring pastel shades that harmonize with the unrenovated structures. The landscaping in the area has not been upgraded. In general, the aesthetic qualities of the buildings have improved after the renovation.

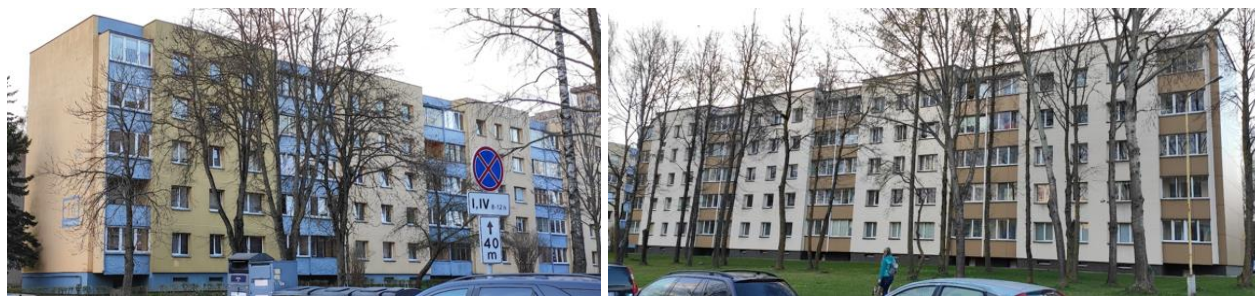
**Fig. 5.** Renovated buildings in the analyzed area. Photographs by Anastasiia Kiuppier  
*5 pav. Renovuoti pastatai analizuojamoje teritorijoje. Anastasiia Kiuppier nuotraukos*

The area includes both renovated and non-renovated apartment buildings (Fig. 5). No ongoing renovation projects were observed. The renovated houses did not lack the aesthetic qualities that non-renovated houses possess, and no new details have been added. Renovated buildings feature changes such as insulation, color change (each building having a distinct color scheme), and in one building ventilation openings were covered that previously served as bird habitats. The buildings exhibit good and medium physical state, with a crumbling plaster on one of the renovated buildings. Renovated facades use such materials as wall plaster or combination of plaster and matte large tile panels. The color palette of the renovated buildings uses pastel shades that are not too bright and saturated. The area's landscaping remains unchanged. Overall, the aesthetic qualities of the buildings have been enhanced following the renovation.

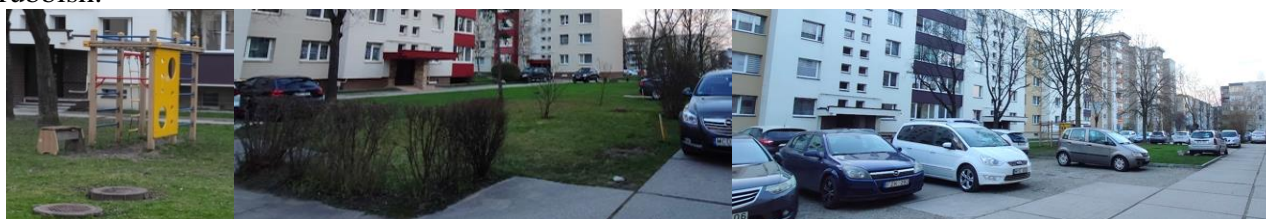
**Fig. 6.** Public spaces lacking amenities and equipment in the observed area. Photographs by Anastasiia Kiuppier  
*6 pav. Viešosios erdvės, kuriose trūksta patogumų ir įrangos stebimoje teritorijoje. Anastasiia Kiuppier nuotraukos*

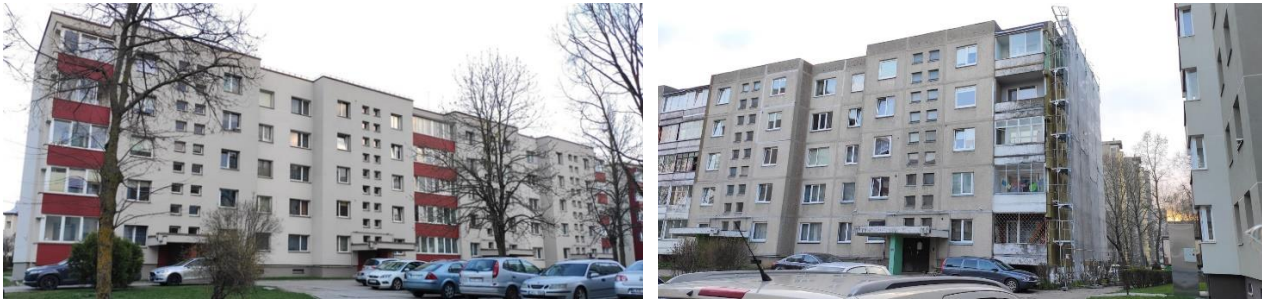
**Fig. 7.** Renovated and non-renovated buildings. Photographs by Anastasiia Kiuppier  
*7 pav. Renovuoti ir nerenovuoti pastatai. Anastasiia Kiuppier nuotraukos*

There are both non-renovated and renovated apartment buildings on this site, and one building is in the process of renovation (Fig. 7). The renovation area is well organized, construction materials are stacked and there is no rubbish outside the fence of the site. Also, the renovated houses were not devoid of any aesthetic qualities that non-renovated houses have and there are no new details. Among the changes are building insulation, changes in color (renovated buildings have more than one color), and the ventilation openings were covered, which in the non-renovated houses serve as housing for birds. No external signs of damage were observed on the buildings, they are in a good physical state. The type of material used on the facades of the renovated buildings is wall plaster. The color palette of the renovated buildings matches their surroundings - the colors are pastel, not too bright, or saturated, only the balconies are red and brown. The landscaping has not been upgraded in this area. As a result of the renovation, there has been a noticeable improvement in the overall aesthetic qualities of the buildings.

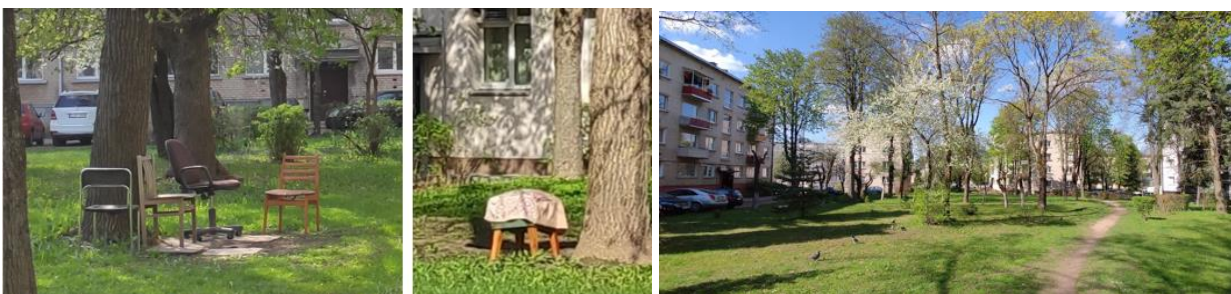
**Fig. 8.** Lots of open green space with no public space amenities observed in the area. Photographs by Anastasiia Kiuppier

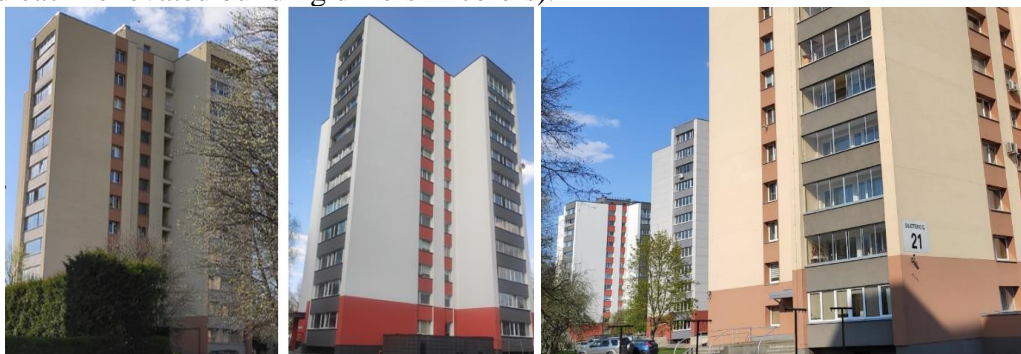
**Fig. 9.** Renovated buildings. Photographs by Anastasiia Kiuppier  
*9 pav. Renovuoti pastatai. Anastasiia Kiuppier nuotraukos*

The area includes both renovated and non-renovated apartment buildings (Fig. 9). Currently, there are ongoing renovation projects, and no rubbish outside the fence of the site is visible. In addition, the renovated houses did not lack the aesthetic qualities that non-renovated houses possess; there were no ventilation openings before, and no new details have been added. Renovated buildings feature changes such as insulation, color change (renovated buildings have more than two colors, and each renovated building differs in colors).

The buildings exhibit a good physical state. Renovated facades exhibit such materials as wall plaster, matte large tile panels, or their combination. The color palette of the renovated buildings uses pastel colors in combination with bright and dark ones - creating a contrast and look

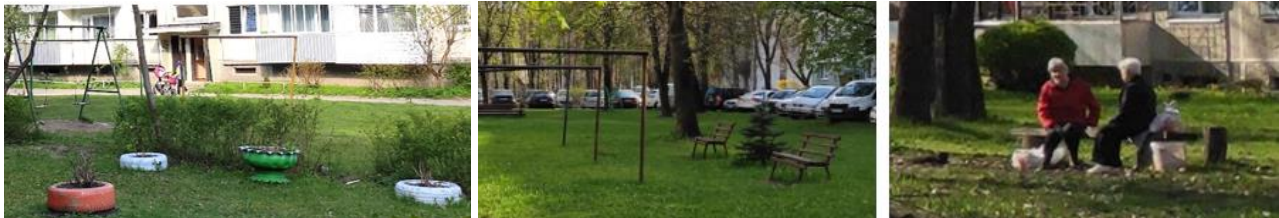
**Fig. 10.** Public space amenities and landscaping created by residents. Photographs by Anastasiia Kiuppier  
*10 pav. Gyventojų sukurta viešųjų erdvių įranga ir akcentai. Anastasiia Kiuppier nuotraukos*

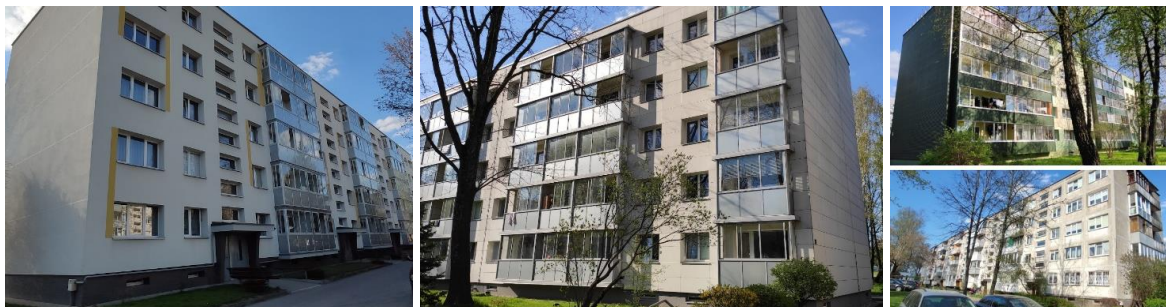
**Fig. 11.** Renovated and non-renovated buildings. Photographs by Anastasiia Kiuppier  
*11 pav. Renovuoti ir nerenovuoti pastatai. Anastasiia Kiuppier nuotraukos*

The area comprises both renovated and non-renovated apartment buildings (Fig. 11). The ongoing renovation of a building is currently underway, displaying a well-organized site where construction materials are neatly stacked, and there is no rubbish or waste outside the fenced area. Furthermore, renovated houses were not deprived of the aesthetic qualities that non-renovated houses have; there were no ventilation openings before, and there are no new details. Renovated buildings exhibit changes such as insulation, changed colors (each building having its own color scheme, and each renovated building differs in colors). The buildings show no external signs of damage. Renovated facades exhibit such types of materials as wall plaster, matte large tile panels, or plaster in combination with corrugated metal sheets. The colors palette of the renovated buildings is pastel or in combination with dark ones - creates a slight contrast but look harmonious in an environment. The landscaping in the area has not been upgraded. In general, the aesthetic qualities of the buildings have improved after the renovation.

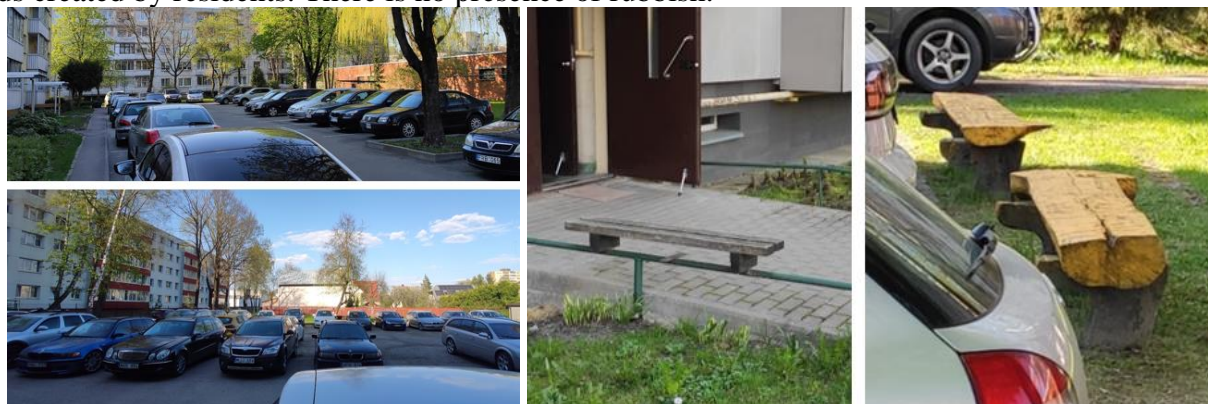
**Fig. 12.** The lack of public green spaces leads to the lack of public space amenities. Photographs by Anastasiia Kiuppier  
*12 pav. Žaliųjų plotų trūkumas lemia viešųjų erdvių patogumų trūkumą. Anastasiia Kiuppier nuotraukos*

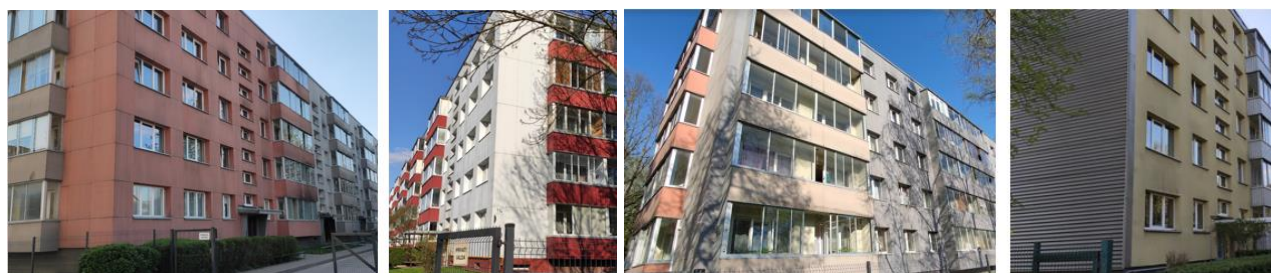
**Fig. 13.** Renovated buildings. Photographs by Anastasiia Kiuppier  
*13 pav. Renovuoti pastatai. Anastasiia Kiuppier nuotraukos*

The area comprises both renovated (Figure 13) and non-renovated apartment buildings. There is no ongoing renovation of buildings. Furthermore, renovated houses were not deprived of the aesthetic qualities that non-renovated houses have; there were no ventilation openings before, and there are no new details. Renovated buildings exhibit changes such as insulation, changed colors (each building having its own color scheme, and each renovated building differs in colors). The buildings show no external signs of damage, and good physical state. Renovated facades used such types of materials as wall plaster, matte large tile panels, or plaster in combination with corrugated metal sheets. The colors palette of the renovated buildings is predominantly pastel, but some buildings are pastel in combination with bright tones and stand out a little in relation to the environment. The landscaping in the area has not been upgraded. In general, the aesthetic qualities of the buildings have improved after the renovation.
